## Fish Passage & Diversion Screening Inventory Database Report Cover Sheet

Road Name:	<input type="text" value="Tyee Rd"/>
Mile Post:	<input type="text" value="-999.99"/>
County:	<input type="text" value="Skagit"/>
WDFW Region:	<input type="text" value="4"/>

## Level A Culvert Assessment Report

Site ID:	999114		
Latitude:	48.319176743	Stream:	unnamed
Longitude:	-122.280296755	Tributary To:	Starbird Cr
		WRIA:	03.0194
		Fish Use Potential:	Yes

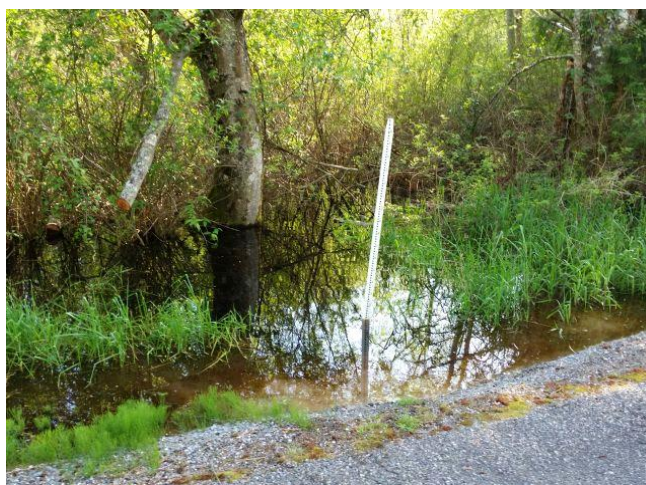
Culvert Details								Level A Parameters					
ID	Shape	Material	Span	Rise	Length	WDIC	Apron	WSDrop	Location	Countersunk	Backwater	Slope (%)	Sediment
1.1	RND	CST	0.46	0.46	10.20	0.46	NO	0.00		No	Yes	2.25	
All dimensions in meters

<b>Assessment Results</b>		Tidal Influence:		Tidegate Present:	No
Barrier:	Yes	Passability (%):	0	Method:	Other
Reason:	Debris	Fishway Present:	No	Recheck:

<b>Comments</b>
Upstream end of pipe mostly filled with debris, blocking flow. Water is flowing over the road.
